# 2015 PAVEMENT CONDITION INDEX (PCI) STUDY **EXECUTIVE SUMMARY**

FEDERAL AVIATION ADMINISTRATION  
A.I.P. NO. 3-38-0000-013-2015

2015 PAVEMENT  
CONDITION INDEX (PCI)  
STUDY EXECUTIVE  
SUMMARY  
[www.aero.nd.gov](http://www.aero.nd.gov)

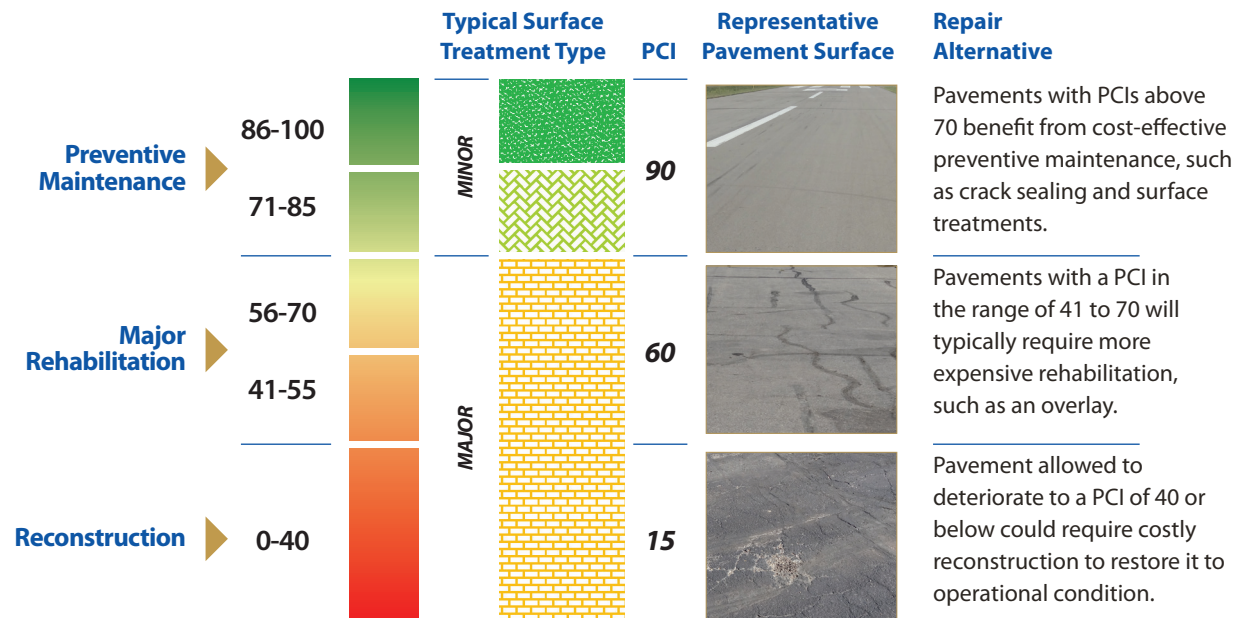
The PCI will also aid in tracking and determining causes of deterioration on a pavement. The correlation between a PCI number and a recommended repair is shown in the illustration to the right. Preventive maintenance consists of patching, crack sealing and joint sealing. Pavement rehabilitation includes surface treatments and thin overlays. Pavement reconstruction refers to full-depth reconstruction and thick overlays. Minor surface treatments are used to address weathering and low-severity raveling. Major surface treatments are used to address medium- and high-severity raveling.
